McDonald's Hamburgers  
1530 First Ave NE  
Major Accessibility Barriers in Design

Peer Action Disability Support (PADS)  
Prepared by Andy Elsbecker  
Student Legal Intern  
University of Iowa Legal Clinic

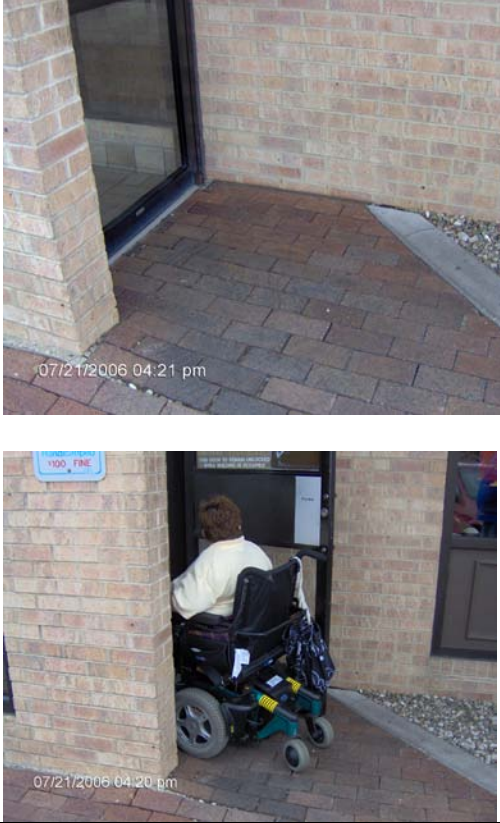
Feature	Photos	Possible Solutions
<p><b>External Doors-</b></p> <p>1) The external doors on the vestibule do not provide enough clear space for those with wheelchairs or walkers to pull the handle and maneuver around the open door. Bricks and rocks near the door limit the space behind a person as they try to open the door and enter the vestibule.</p> <p>2) Signage- Neither external door into the vestibule is designated as the accessible entrance.</p>

<p><b>Clear Space</b></p> <p>Preferred Solution: Remove or alter the landscaping to provide 5 feet of clear space perpendicular to the door.</p> <p>Alternative Solution: Provide a power door to allow for access into the vestibule</p> <p><b>Signage-</b></p> <p>Solution: Provide a sign clearly designating the right entrance (facing the vestibule) as the accessible entrance.</p>

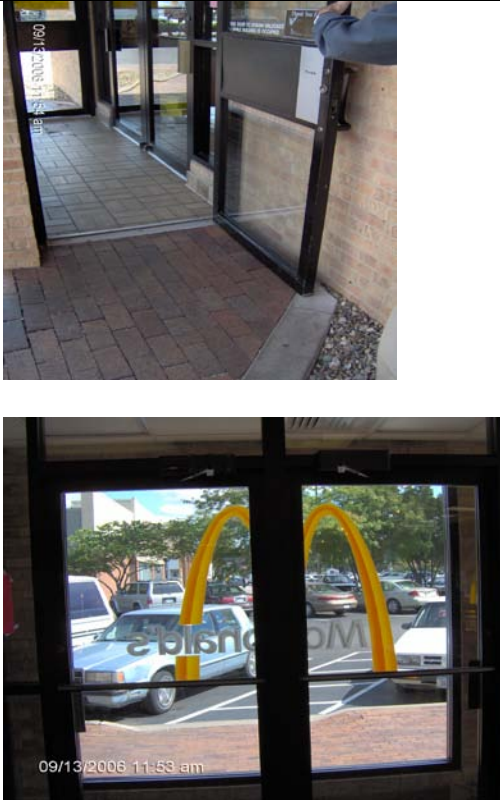
Feature	Photos	Possible Solutions
<p><b>Doors In Vestibule-</b></p> <p>The current design presents an enormous barrier to entry for persons with disabilities. When entering from the right, the first door is hinged on the right. The door swings awkwardly away from a person in a wheelchair, requiring them to attempt to prop the door open (possibly with their chair) and attempt to maneuver into the building. It is also impossible to enter the building through the left-hand door since it opens into the center and does not allow for nearly enough space to maneuver around and into the restaurant.</p>

<p>Preferred Solutions:</p> <ol style="list-style-type: none"> <li>1) Redesign the vestibule to provide for direct entry into the restaurant.</li> <li>2) Remove one or both of the inner doors in the vestibule</li> </ol> <p>Alternative Solution:</p> <ol style="list-style-type: none"> <li>1) Provide a buzzer/doorbell to notify employees to help a customer enter the restaurant.</li> </ol>

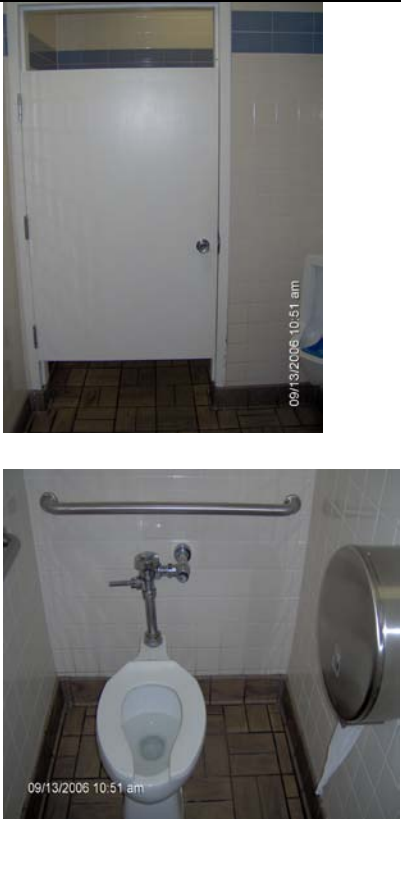
Feature	Photos	Possible Solutions
<p><b>Bathroom Interior-</b></p> <p>1) Stall Door Handles- The door handles on the stalls require grasping and turning of the wrist.</p> <p>2) Toilet- The toilet in the women's restroom stall is too low. It is approximately 14" tall. This makes transfers from a wheelchair to the toilet difficult and dangerous.</p>

<p>1) Stall Door Handles- Install sliding lever style door hardware.</p> <p>2) Toilet- Replace existing toilet with a taller model</p>

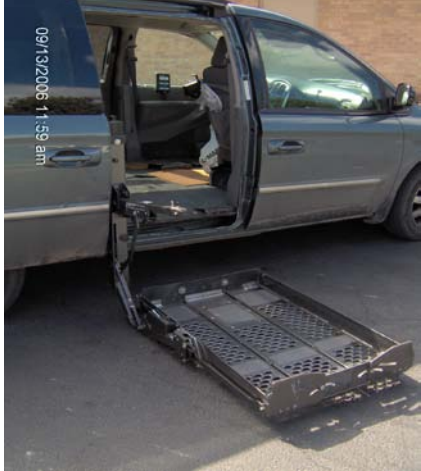
Feature	Photos	Possible Solutions
<p>1) Not Enough Accessible Parking- There are currently two accessible parking spots. There should be three for a parking lot of this size.</p> <p>2) Van Accessible Parking- One spot should be van accessible. One of the two current spots appears to meet the ADA's requirements for a van accessible parking stall.</p>

<p>1) Provide another accessible parking stall</p> <p>2) Designate the larger accessible spot "van accessible" by placing a sign beneath the current sign.</p>
